Progress MS-04 fails to reach orbit

A fresh cargo ship lifted off from Baikonur on Dec. 1, 2016, heading to the [International Space Station](#), ISS. However six minutes after the liftoff, telemetry stopped coming from the mission during the powered flight of the third stage of the Soyuz-U launch vehicle.

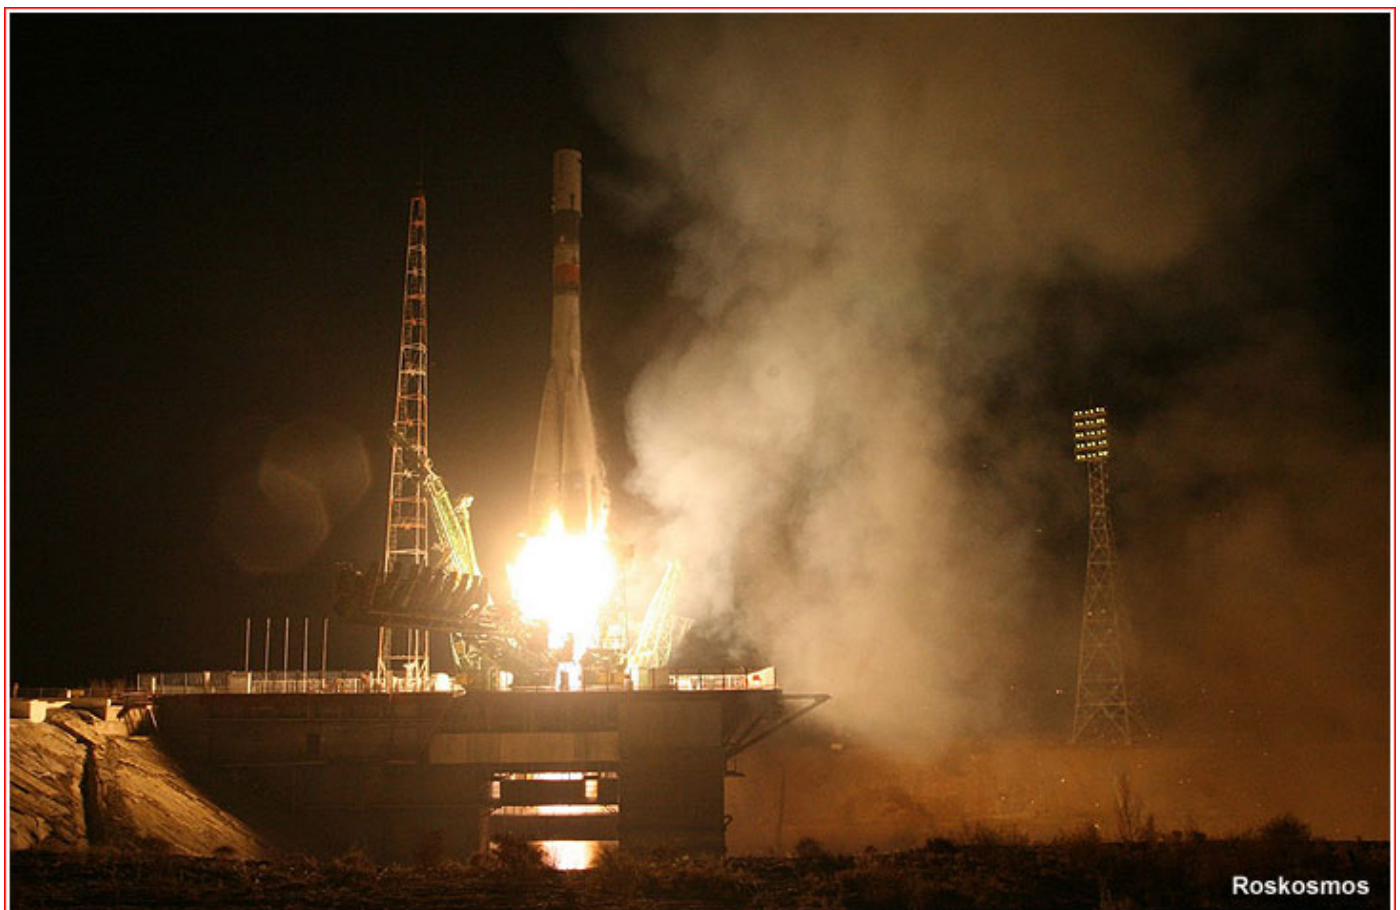
A Soyuz-U rocket with Progress MS-04 lifts off on its ill-fated mission on

Dec. 1, 2016.

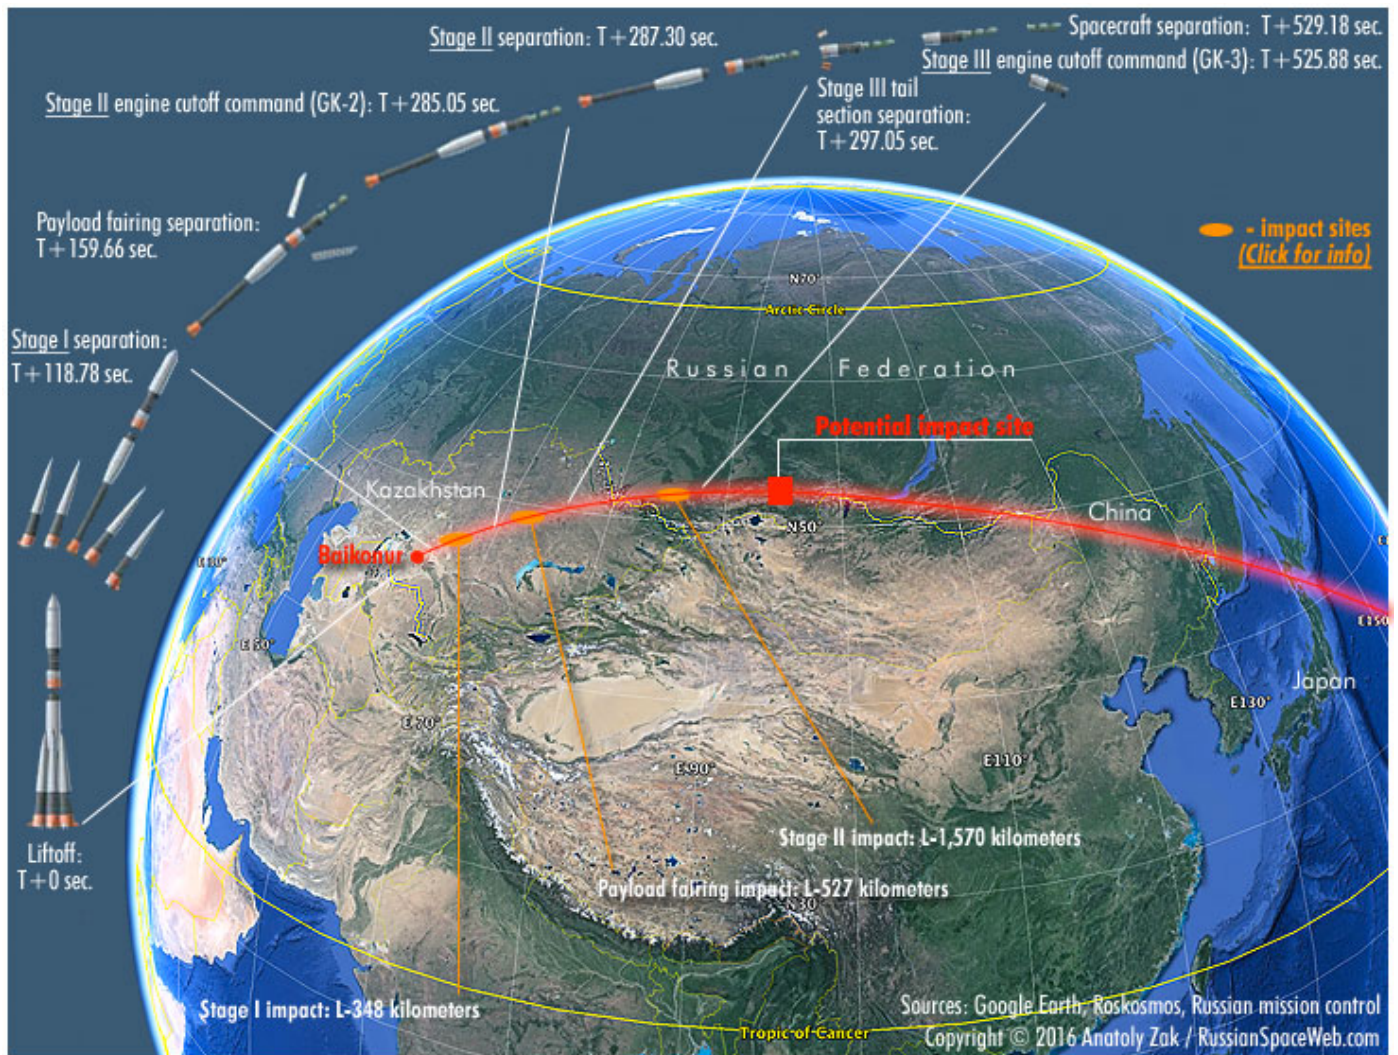
Progress MS-04 crashes in Southern Russia

Four hours after the failed launch, Russian media reported that the crash site had been located in the heavily wooded area of the Choisky District in the Tuva Republic, around 40 kilometers from the nearest residential area. The site was reportedly secured, but the arrival of space officials to this remote area by helicopter was hampered by bad weather.

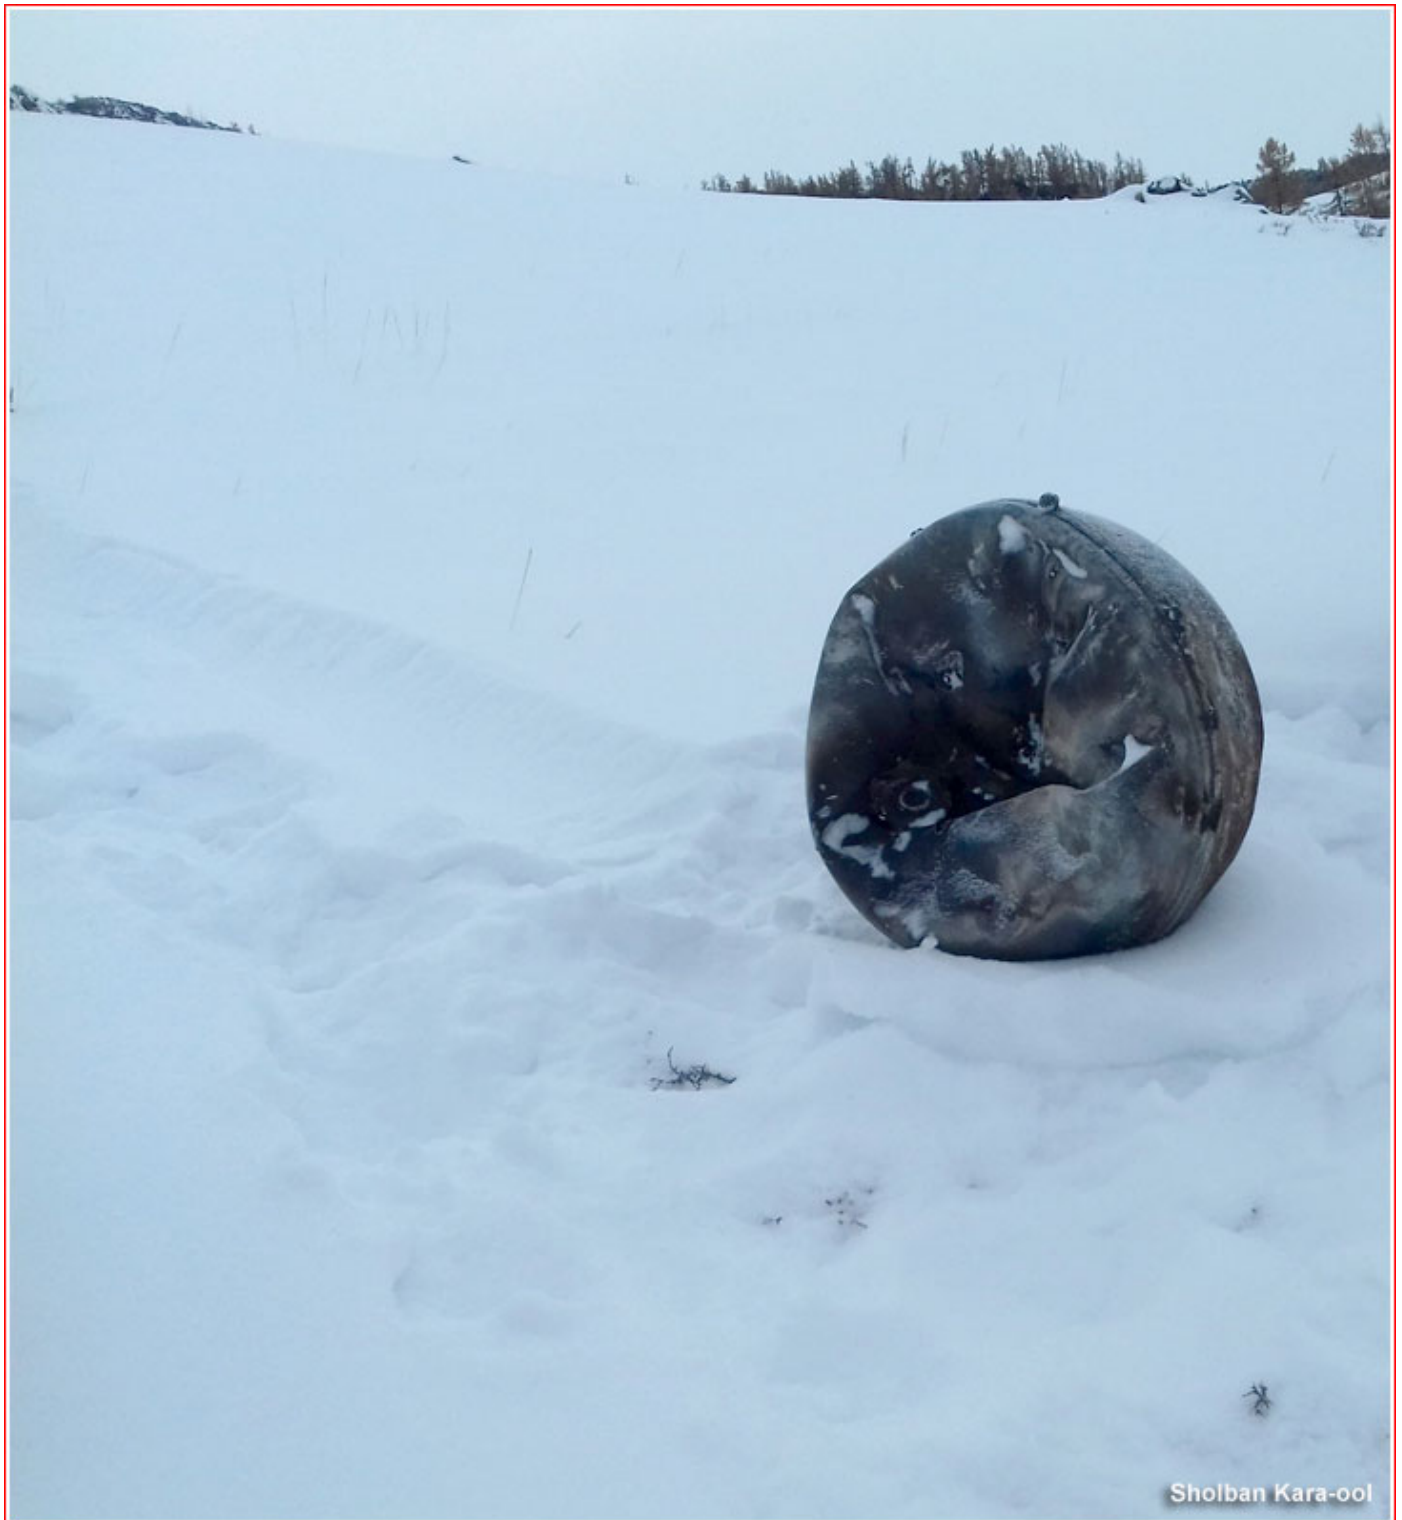
The investigation begins into the Progress MS-04 launch failure

Based on the preliminary analysis of the accident, all transmissions from the BR-92R-7M telemetry system on the Soyuz-U rocket ceased abruptly at L+382.3 seconds in flight at an altitude of 181 kilometers, *RIA Novosti* reported. No issues with the flight had been detected until that moment. During the ascent, all the telemetry from the rocket and from the spacecraft is transmitted to [ground stations](#) via antennas installed in the intertank compartment, MBO, of the [third stage](#).
